Mitigation Plan Review

Site Selection

Riverine Systems

Michelle Mattson
Restoration Ecologist
USACE, IWR
21 March 2019

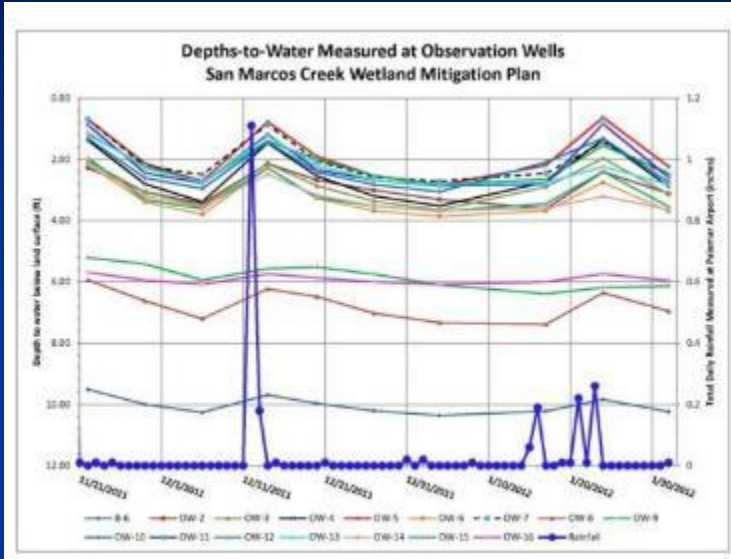
Subsurface hydrology observations

Example: Proposed mitigation is establishment of floodplain alkali marsh wetlands primarily supported by shallow groundwater. We need groundwater monitoring data to determine grading elevations.

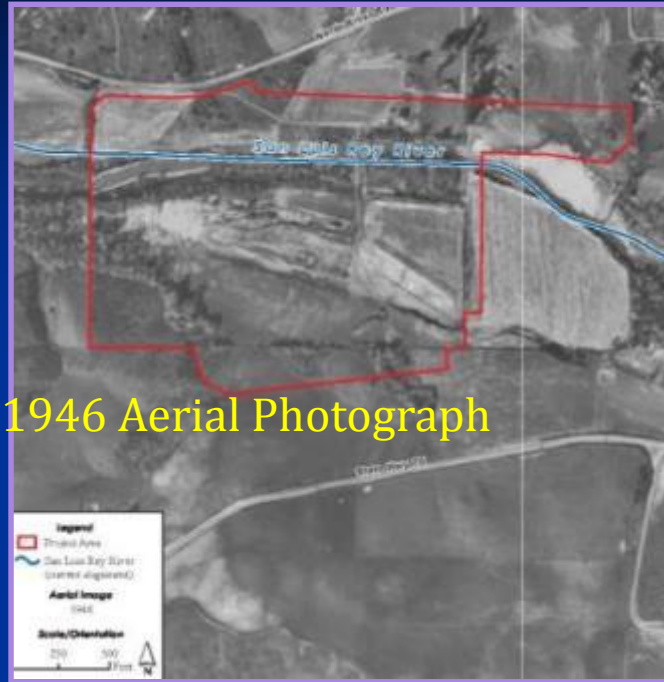
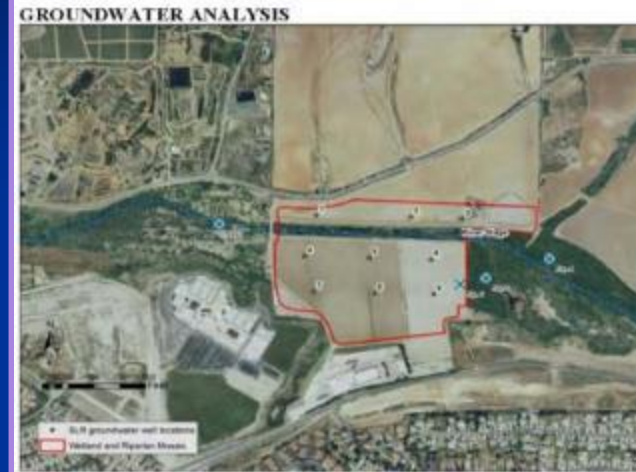
Figure 7. Location of groundwater monitoring wells on the SLRMB, and Figures 3-6. Photo source: Wildlands, 8/1/11

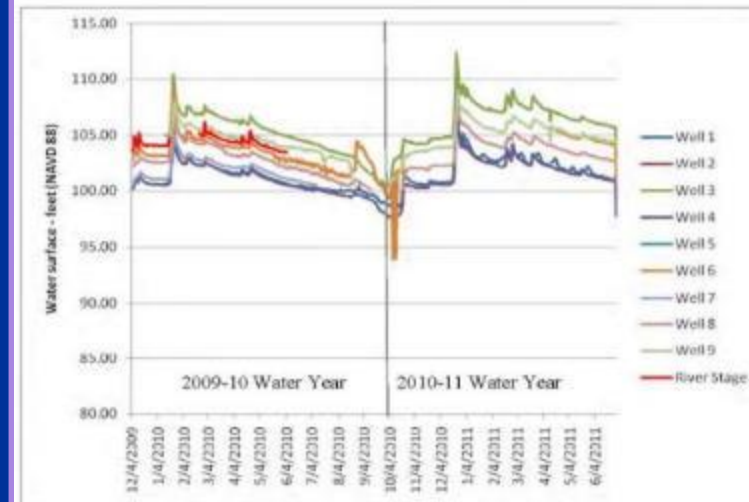
Figure 8. Groundwater elevation and river stage for the SLRMB (river stage is taken for eastern and not adjusted for gradient across the site). Data source: Wildlands, 1/8/11.

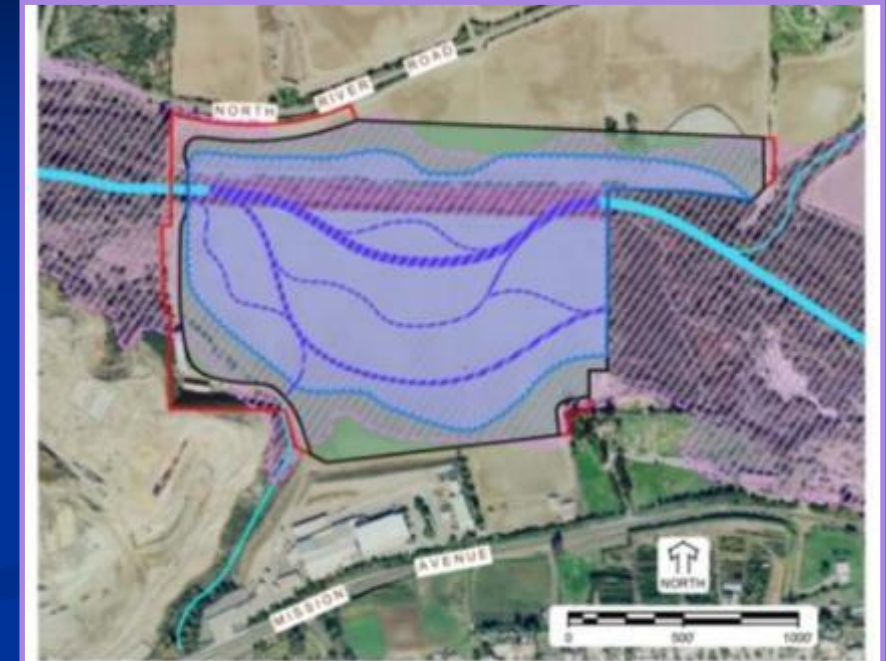
August 2, 2011 - Figure 18
Preliminary Concept Plan

San Luis Rey Mitigation Bank
Prospectus

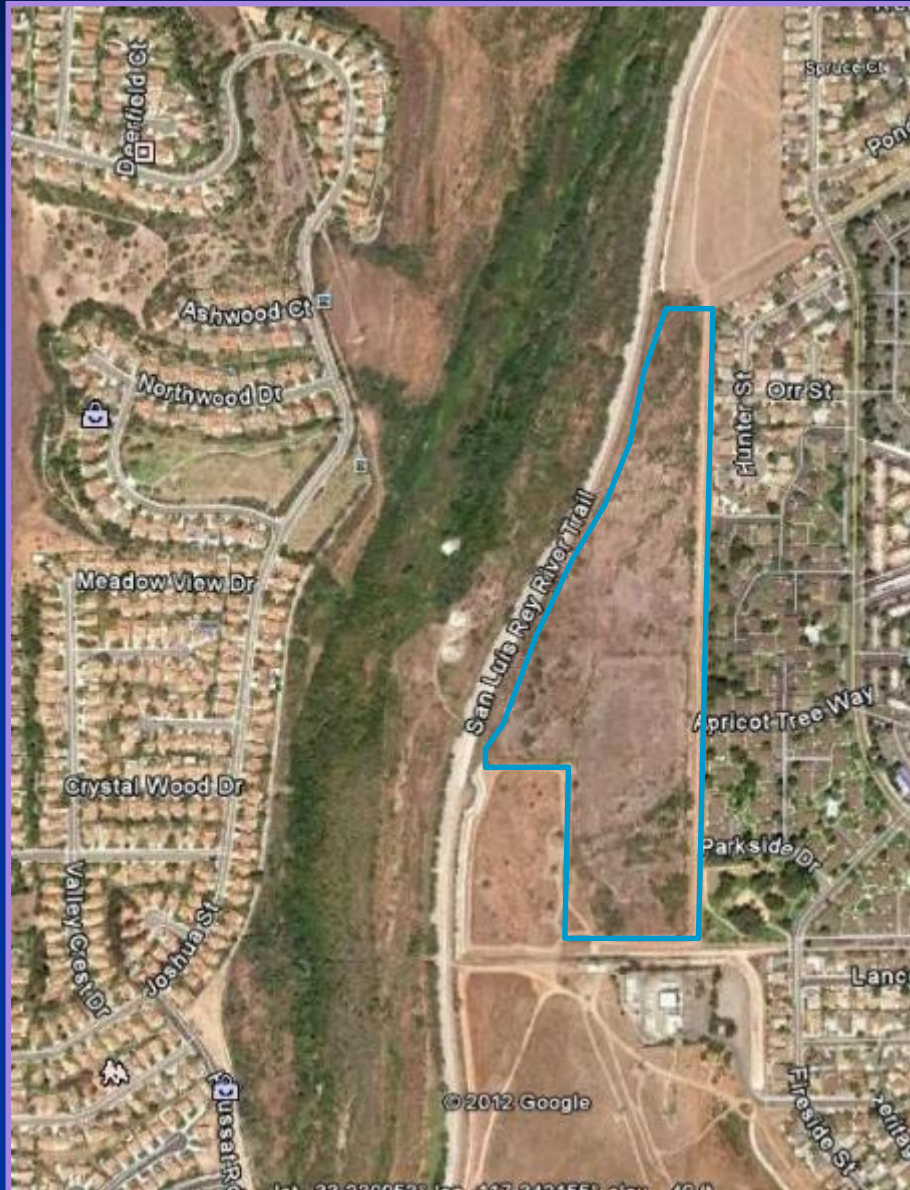
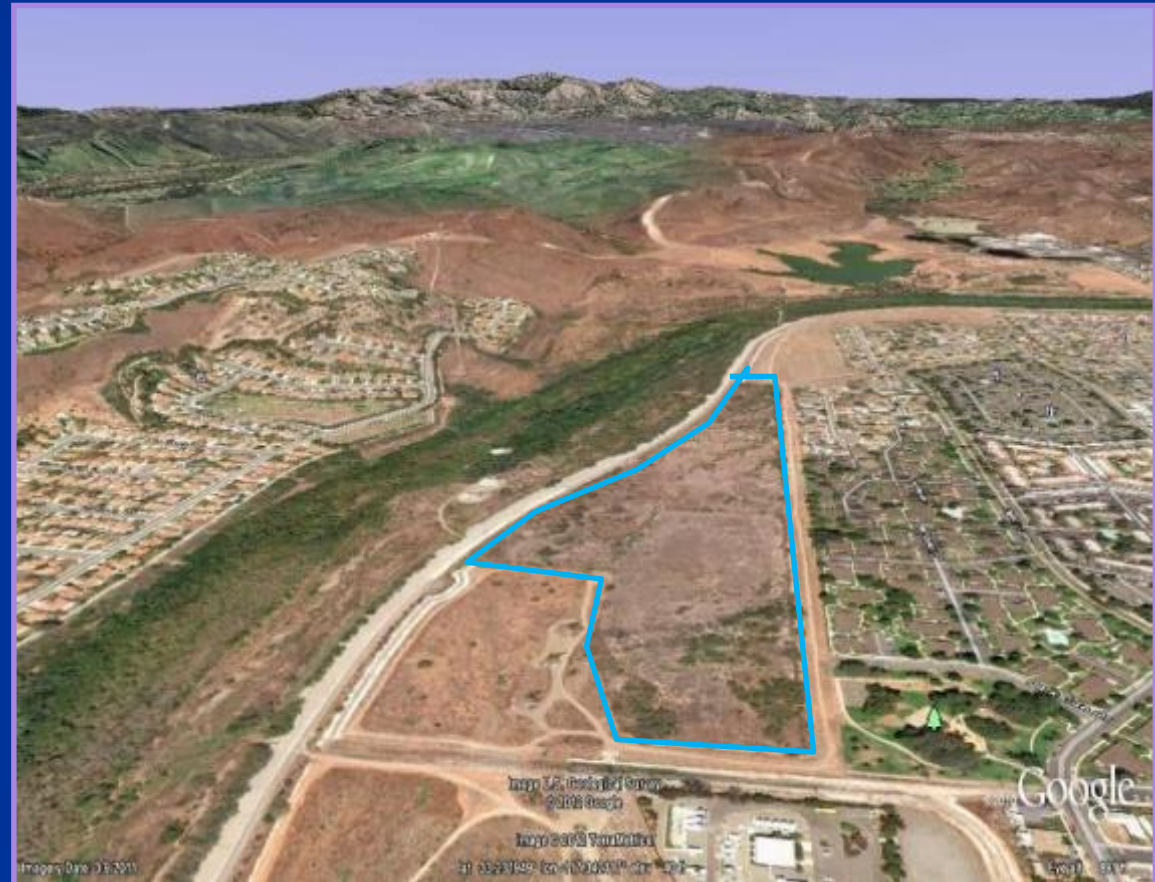
Corps San Luis Rey Mitigation Site:

No hydrologic connection to river
