Integrated Stream and Wetland Design: A
Watershed Approach to Restoring
Ecosystem Functions and Services on the
Landscape.

Curtis J. Richardson, Neal Flanagan, & Mengchi Ho
Duke University Wetland Center, Durham, NC, USA

Stream Wetland Assessment Management Park

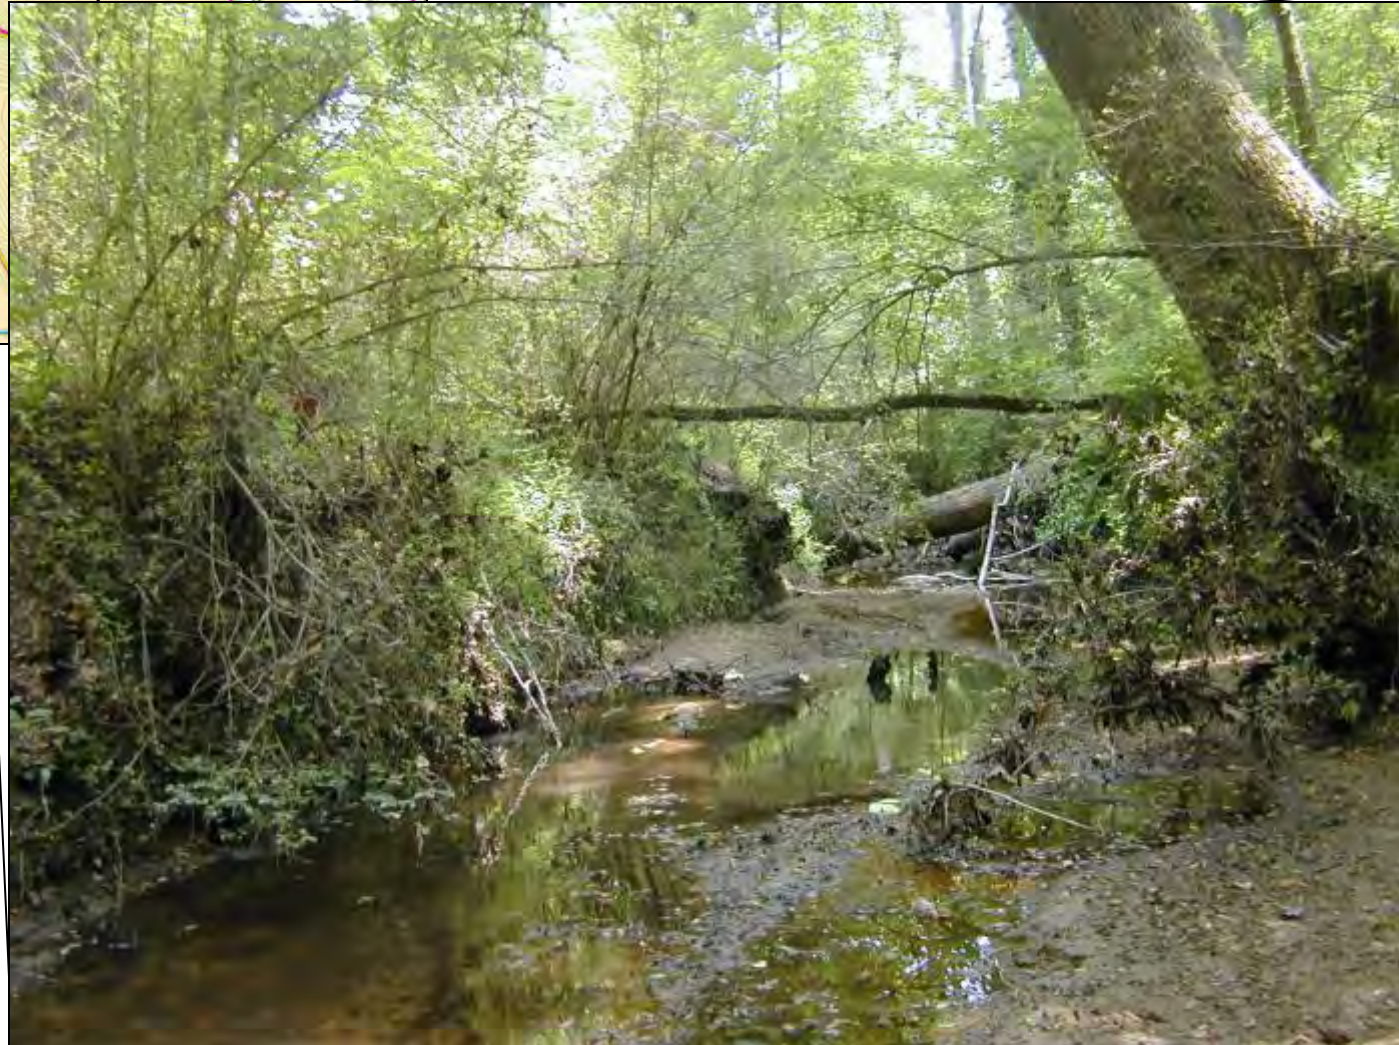
Phase 1: PRECONSTRUCTION STREAM CHANNEL

**DUWC SITE
WT-6
19 May 2003**

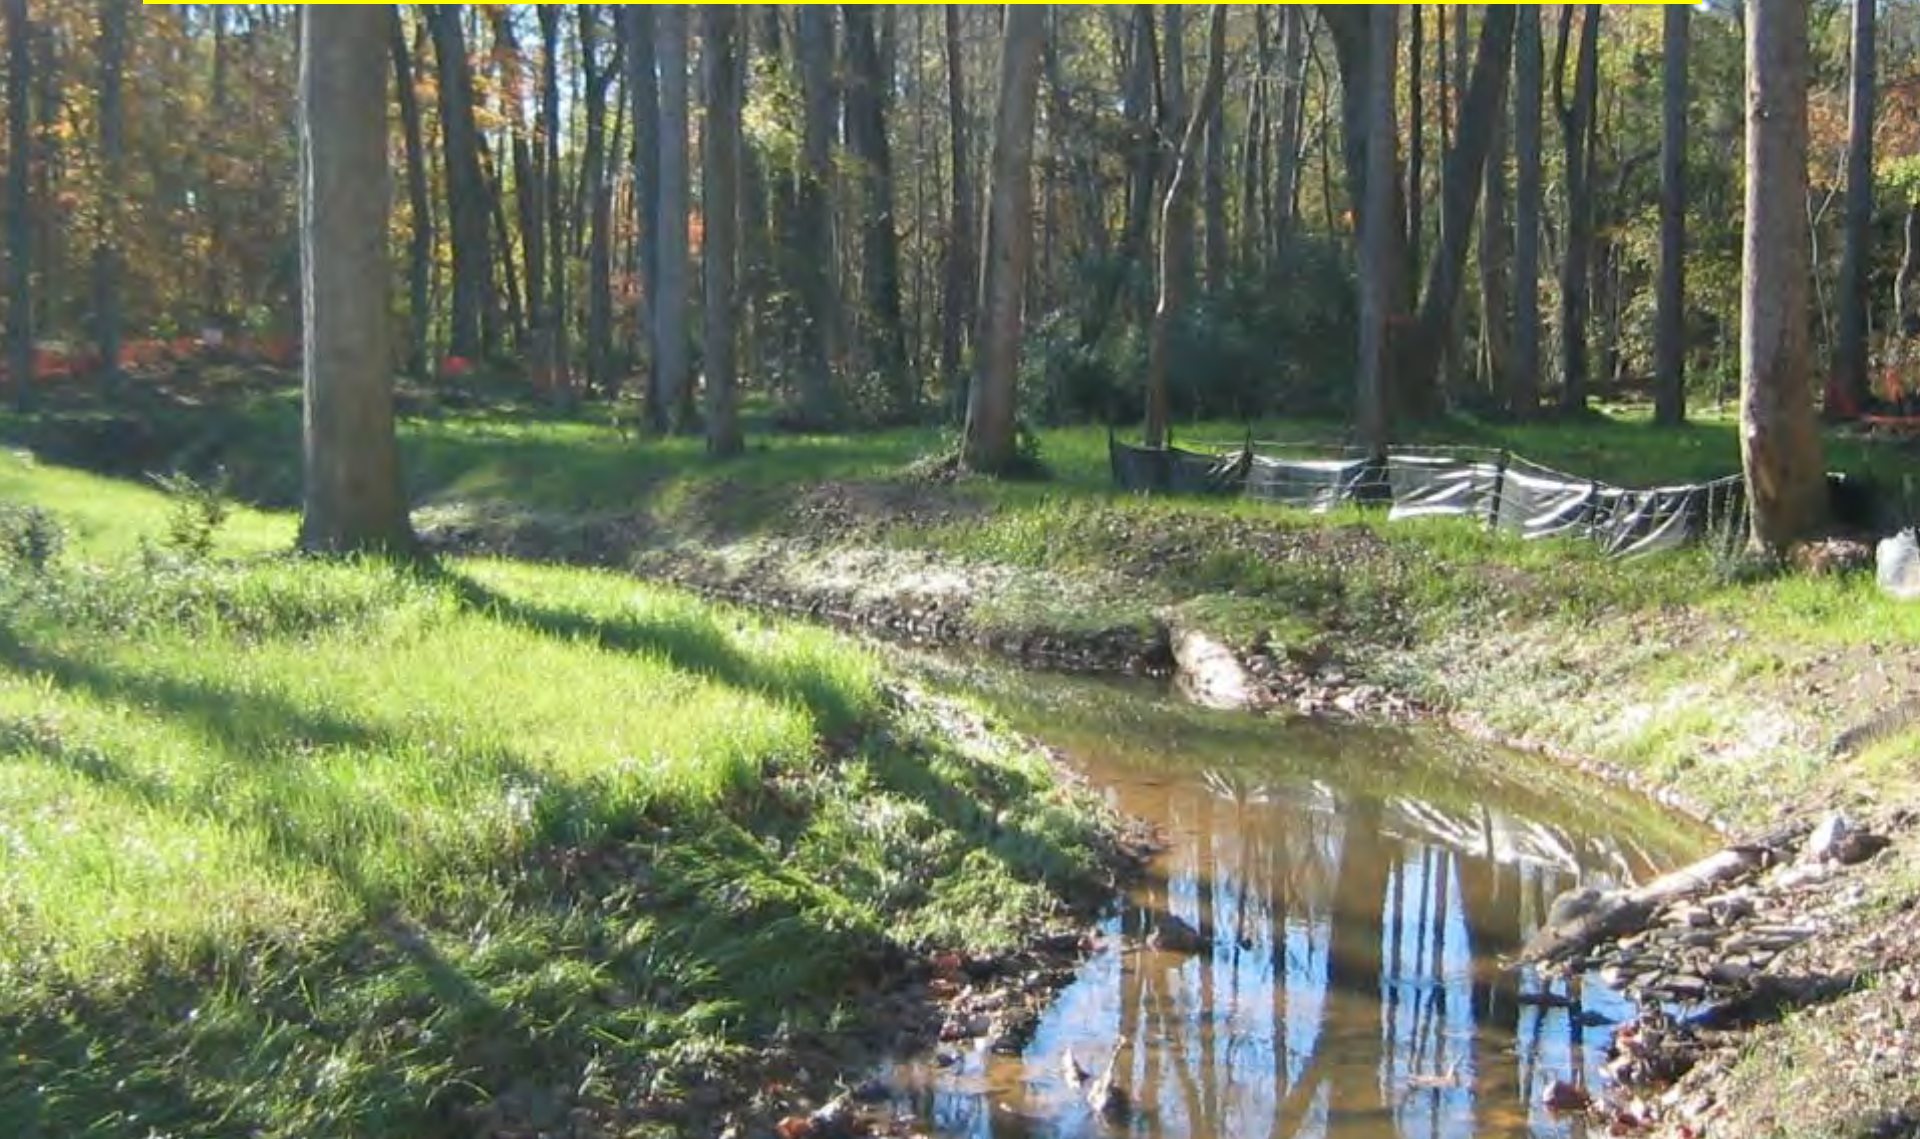
New Channel Configuration

2005

- **Utilize Reference Reach & Natural Channel design Approach**
 - Duke Wetland Center Modifications
- **Determine Stabilization Needs**
 - Vegetation (native species)
 - Root wads (natural design)
 - Cross vanes (engineering design)
- **Raised Stream Bed**
 - Stream Bank Depth = 1.5 meters (59 inches)
 - Lower Bound Storm Depth
 - Bankfull flooding frequency design
1.67/yr rate of return (modified)
 - Create pools, riffles and contours

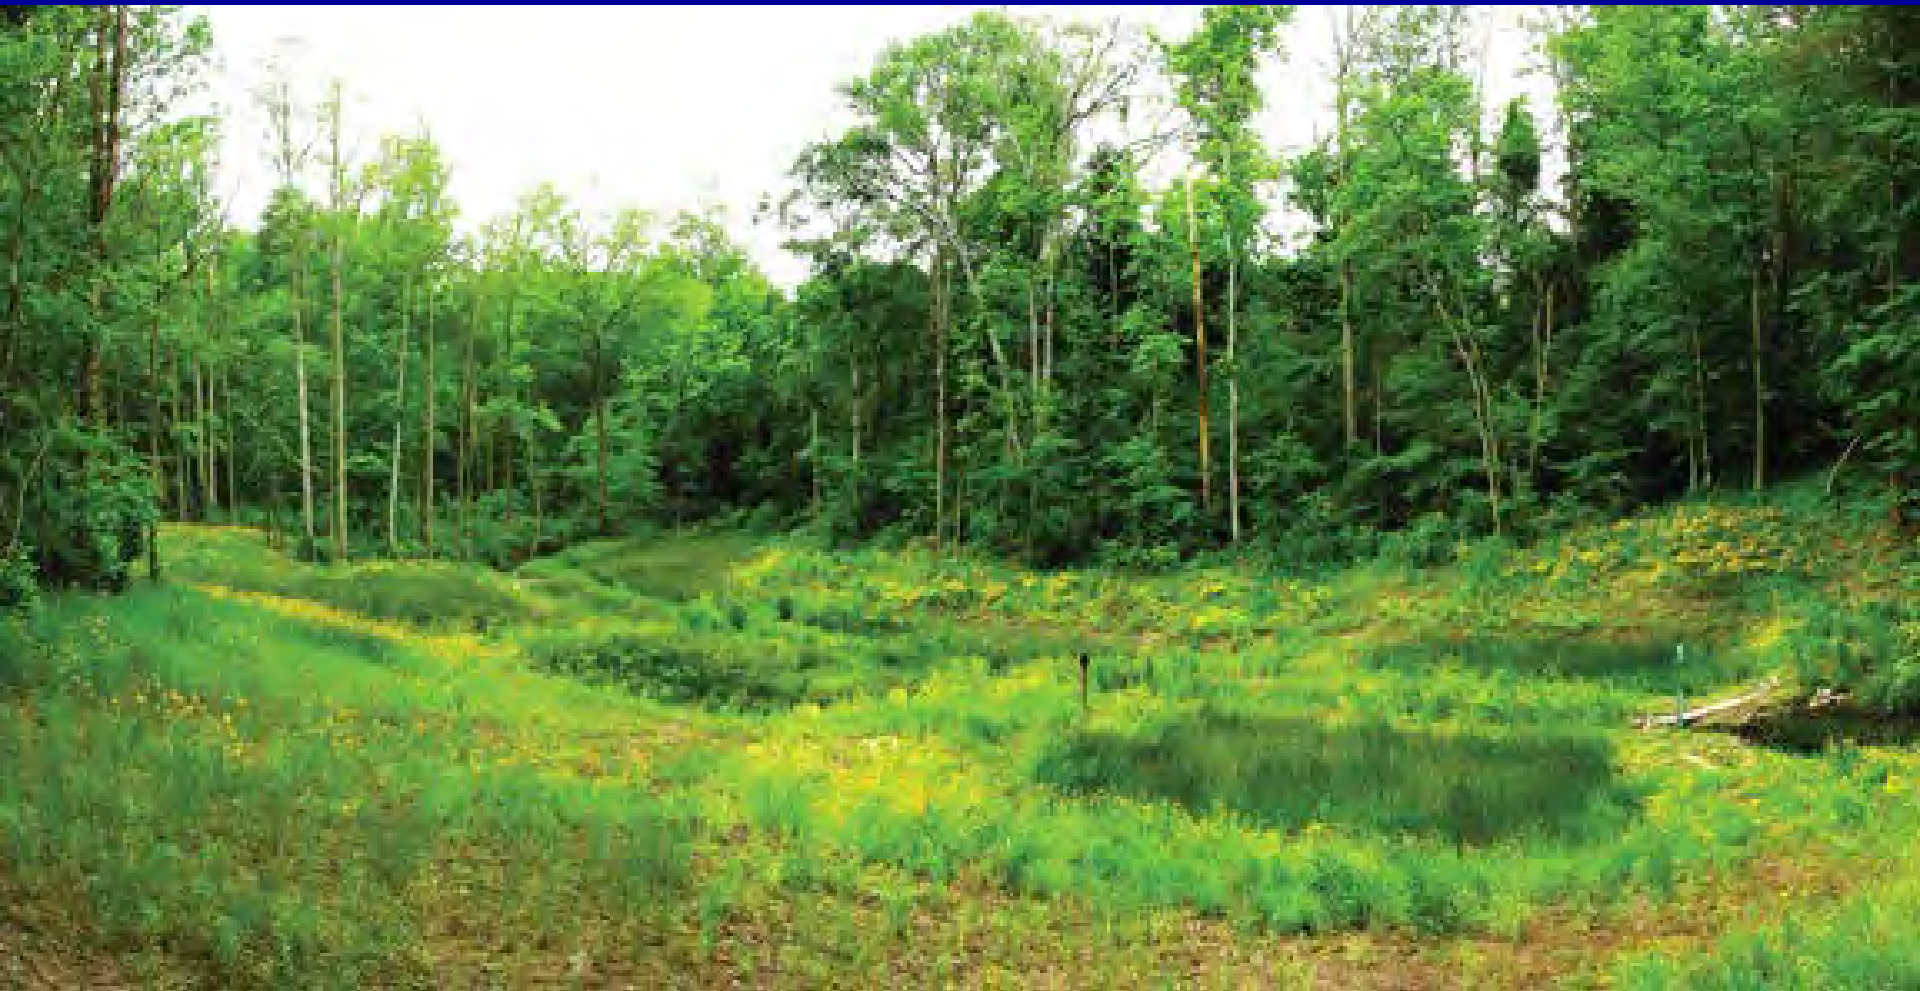
Phase III constructed wetland 2007

Storm water diverter / Weir

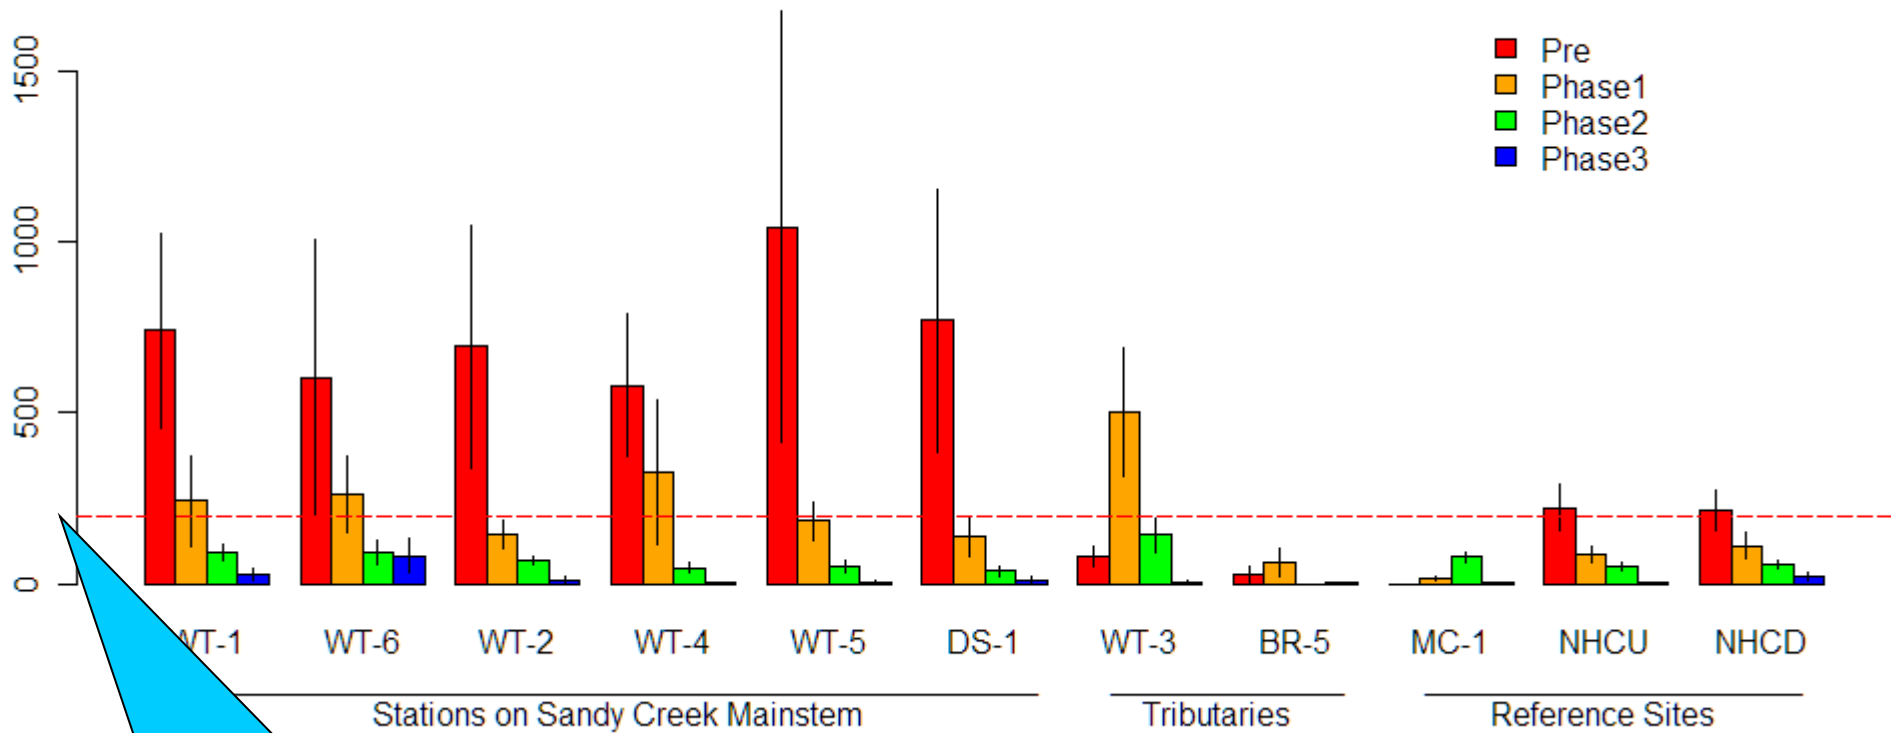
Fecal Coliforms

State of North Carolina ambient criteria

- Significant decreases in fecal coliform, Nitrate, TN, TP, TSS after 3 phases restored
- Preliminary storm mass balance calculations indicate (NO₃- NO₂)-N loads were reduced by 64% and TP by 28%
- Total annual N (26%) and P load stream reductions (20%) after 4 phases.
- 488 MT of sediments retained Annually, mostly stored in the floodplain wetlands
